Public Buildings Enhanced Energy Efficiency Program

Final Report Investigation Results For Department of Transportation Building

Department of Transportation Building Energy Investigation Overview

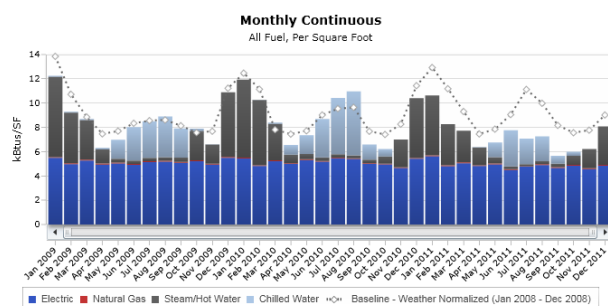
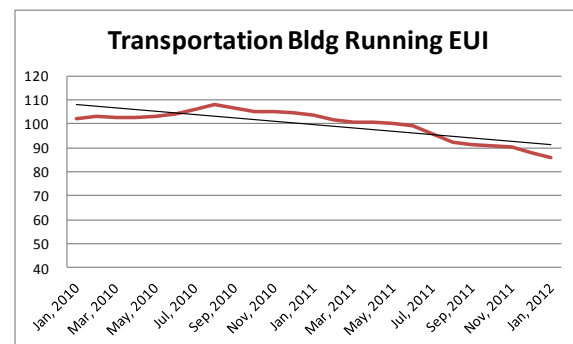
Department of Transportation Building Consumption Report
Total energy use decreased 15% during the period of the investigation

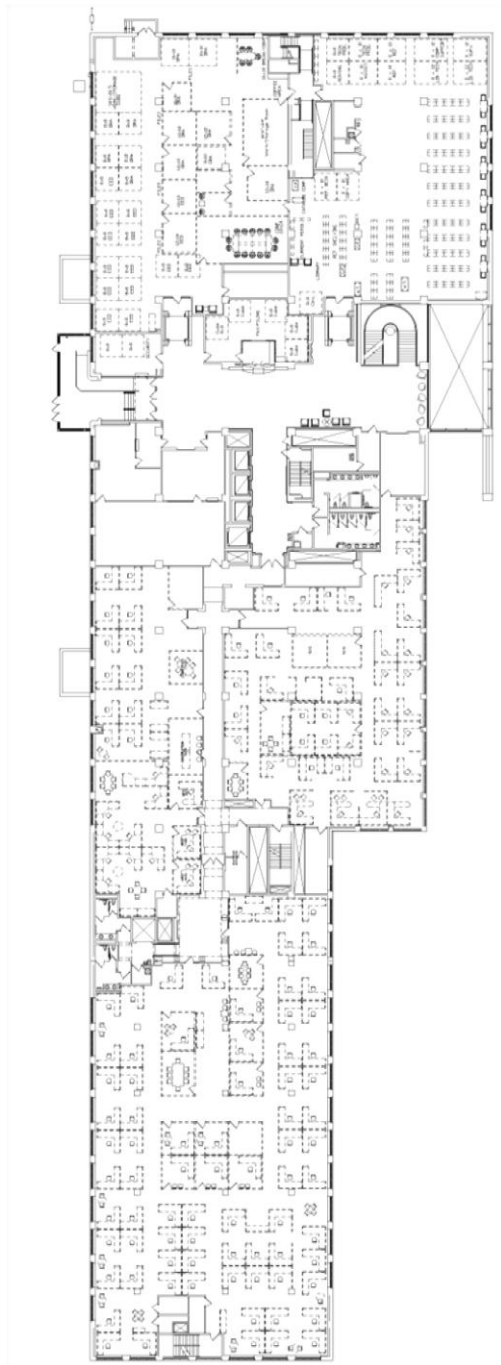
First Floor

Building Floor Plans
